SAUGATUCK RIVER BASIN
WESTPORT, CONNECTICUT

LEE'S POND DAM
CT 00061

PHASE I INSPECTION REPORT
NATIONAL DAM INSPECTION PROGRAM

SEPTEMBER 1980

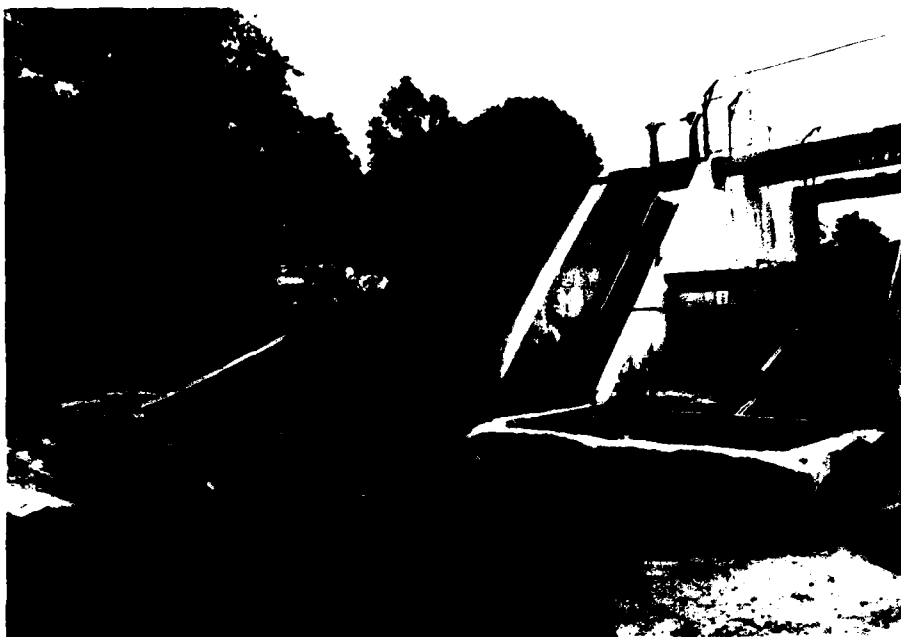
PHOTO 5
SPILLWAY APRON SCOUR POOL

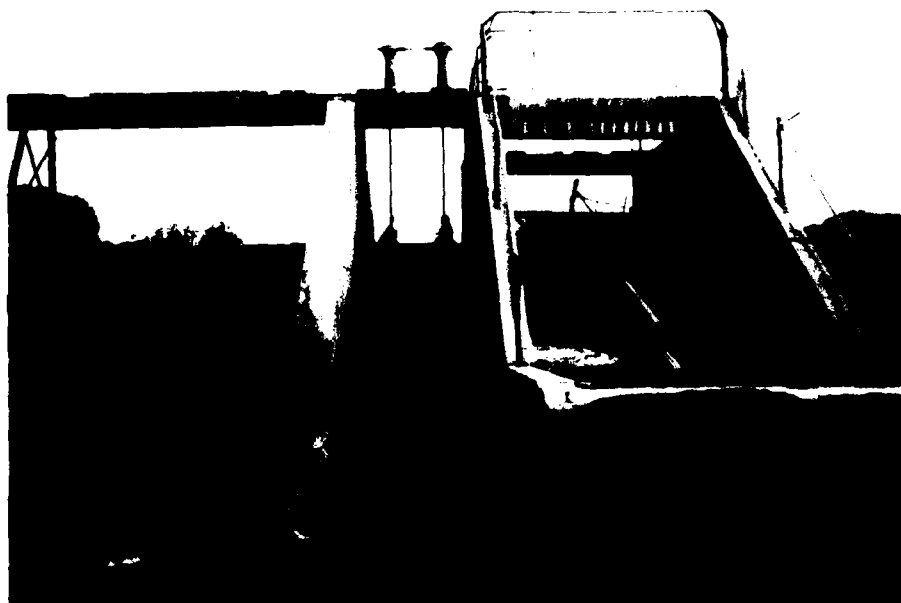
The sluice gate is a wooden gate that has several leaks in it. According to the owner, the gate is operable, however, its actual integrity is questionable (Photo 6). The concrete making up the sluiceway has several areas that are in poor condition with spalled and eroded concrete and exposed reinforcements (Photos 5 and 6). The operating mechanism for the sluice gate is in fair condition, but the location of the handle is unknown.

PHOTO 6
SLUICE GATE - FISHLADDER
